PSS Shaft Seal Maintenance & User Guidelines

*For Sport Boats Using Standard Speed
1-1/8" Seals With 1-3/4" Stern Tube*

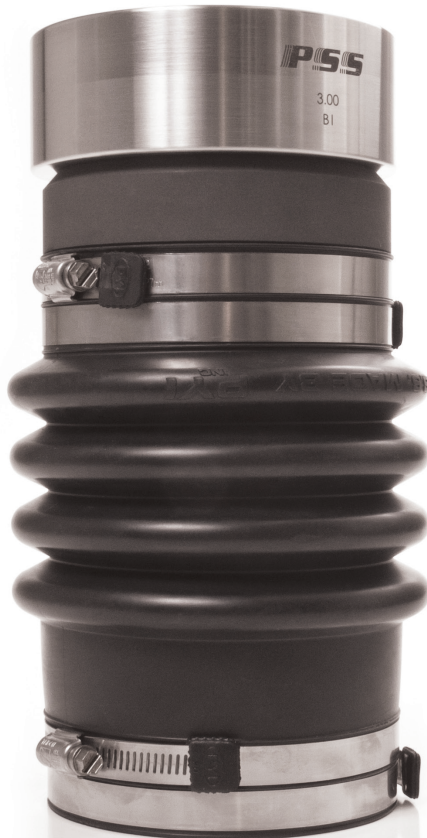
The black carbon ring has a chamfer (bevel) machined into it where it contacts the stainless steel rotor that acts as a wear indicator. If at any time chamfer area is worn away, please contact PYI Inc.

This is typically caused by not enough compression. The compression dimension provided in the "Bellow compression chart" in the instructions is an average figure provided as a guide. The exact amount of compression required can vary due to different types of engine mounts. The **Installed Length** for this seal is 5¼" to 5½" as shown on the diagram. If you experience any spray or mist following the break in period, measure the installed length, and adjust the seal as needed for an installed length of 5¼".

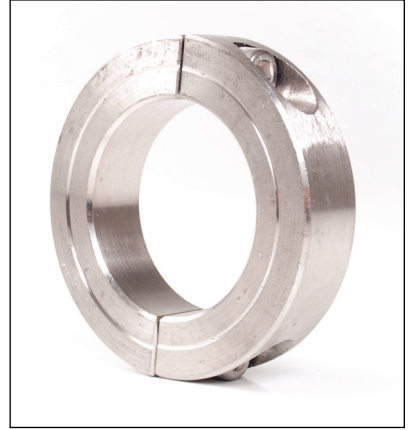
SRC

Shaft Retention Collar

- *Designed to protect propeller and rudder shafts*
- *Assists in keeping the shaft and rudder in the boat in the event of a coupling failure*
- *Easy installation with the shaft or rudder in place*

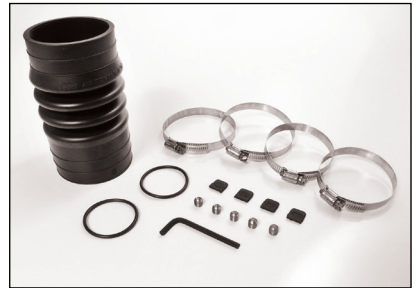
PSS Shaft Seal

Maintenance Kit

It is recommended that you replace your rubber bellows once every six years. The maintenance kit includes new:

- *Rubber bellows*
- *Nitrile o-rings*
- *Set screws*
- *Hose clamps*

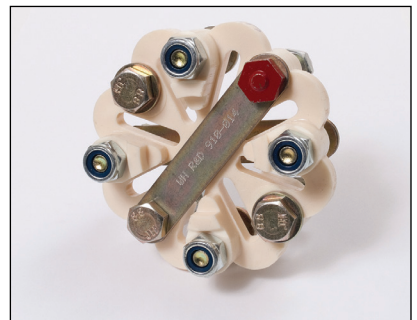
Flexible Shaft Coupling

- *Reduces engine noise & transmission vibration*
- *Fail safe design*
- *Reduces costly transmission repairs*
